UNDERWATER BRIDGE INSPECTION REPORT

STRUCTURE NO. 90608

MINNETONKA BOULEVARD

MINNESOTA DEPARTMENT OF TRANSPORTATION
UNDERWATER BRIDGE INSPECTION

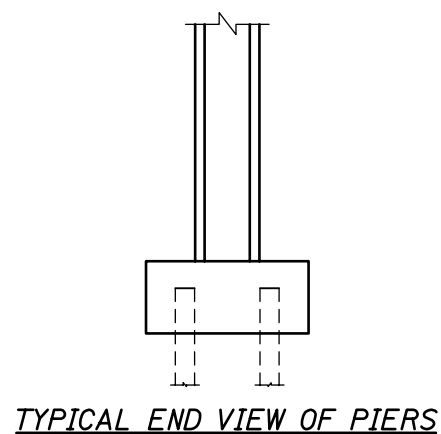
INSPECTION AND SOUNDING PLAN

- The channel bottom material consisted of firm silty sand with up to 4 inches probe rod penetration.
- An area of section loss was observed on the northwest corner of the west end of Pier 1 and was located 1 foot below the waterline measuring 6 inches high by 18 inches wide with 1 inch maximum penetration.

- An area of section loss with exposed reinforcing steel was observed 1 foot above the waterline measuring 4 inches in diameter with a penetration of 1 inch.

- Horizontal cracks were observed near the waterline. The cracks were typically 7 feet long with 1/16 inch maximum width.
- A vertical crack was observed near the center of the pier and extended from pier cap to the channel bottom with 1/8 inch maximum width.

- An area of section loss with exposed reinforcing steel was observed at the east end of Pier 1 and extended from the top of the pier cap to 4 feet above the waterline measuring up to 3 feet in width with penetrations up to 3 inches deep.

- An area of section loss with exposed reinforcing steel was observed at the east end of Pier 1 from the top of the pier cap to 1 foot below the waterline measuring 6 to 18 inches wide with penetrations up to 5 inches deep.

- Channel bottom consisted of scattered 1 to 3 foot diameter riprap with scattered 6 inch cobbles.
- An area of section loss with exposed reinforcing steel was observed at the southwest corner at the west end of Pier 2 and was located 1 foot above the waterline measuring 1 foot in diameter with a penetration of 1.25 inches.

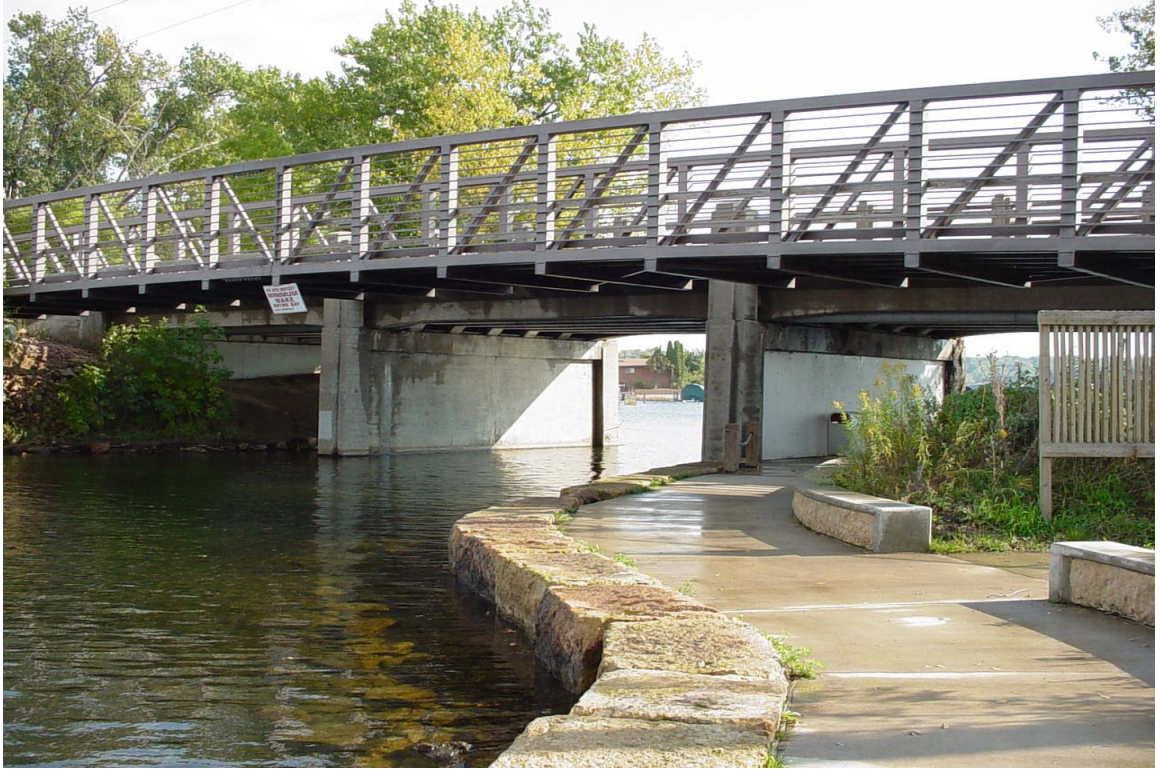
Photograph 1. Overall View of Structure, Looking Northeast.

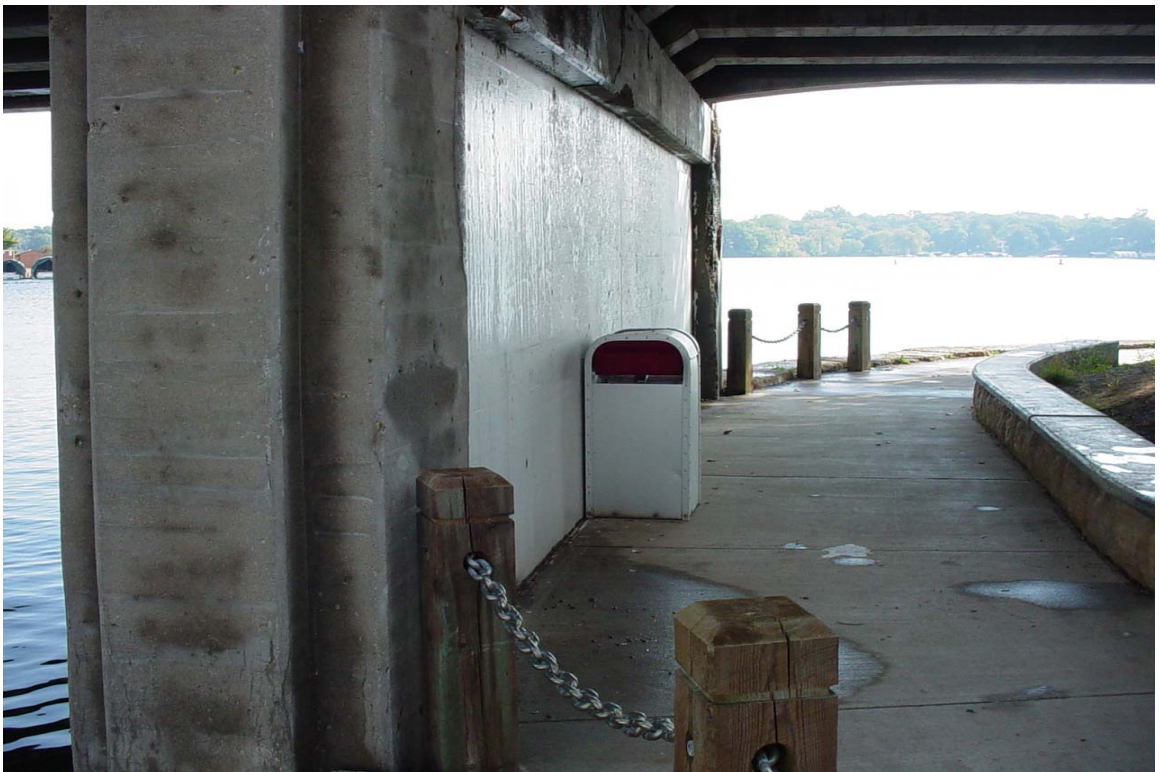
Photograph 2. View of Pier 1, Looking Northeast.

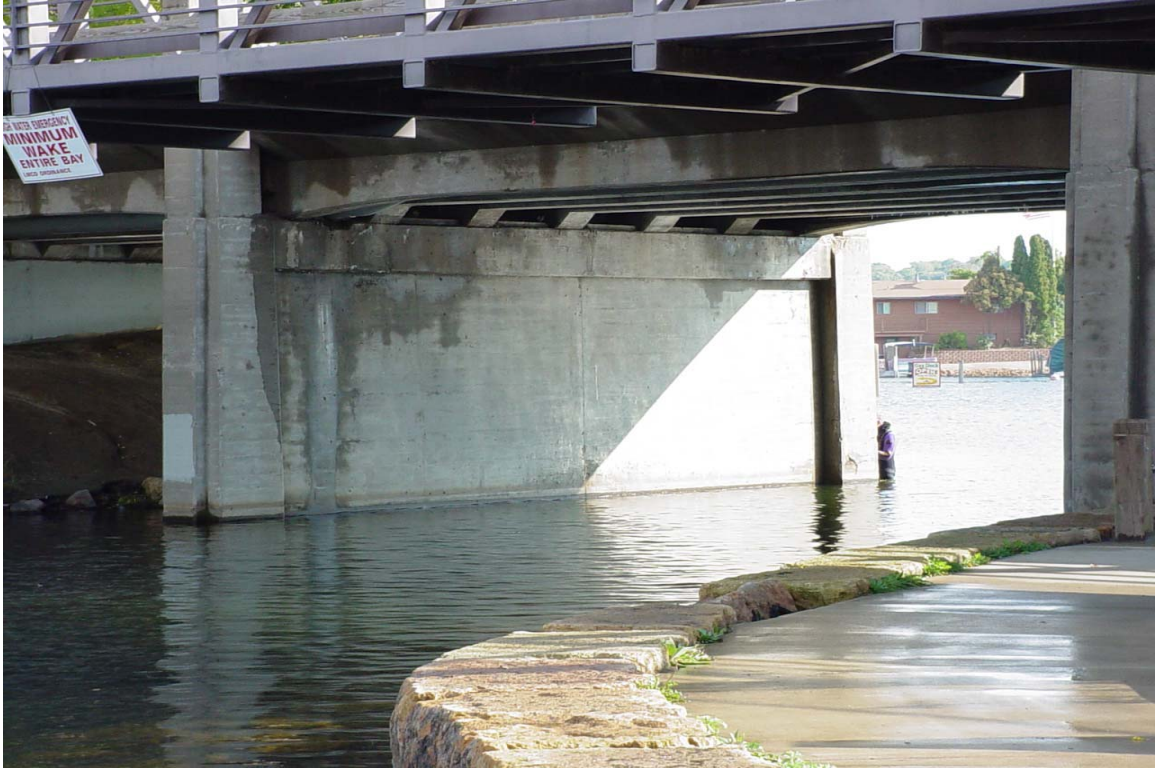
Photograph 3. View of Pier 2, Looking Northeast.

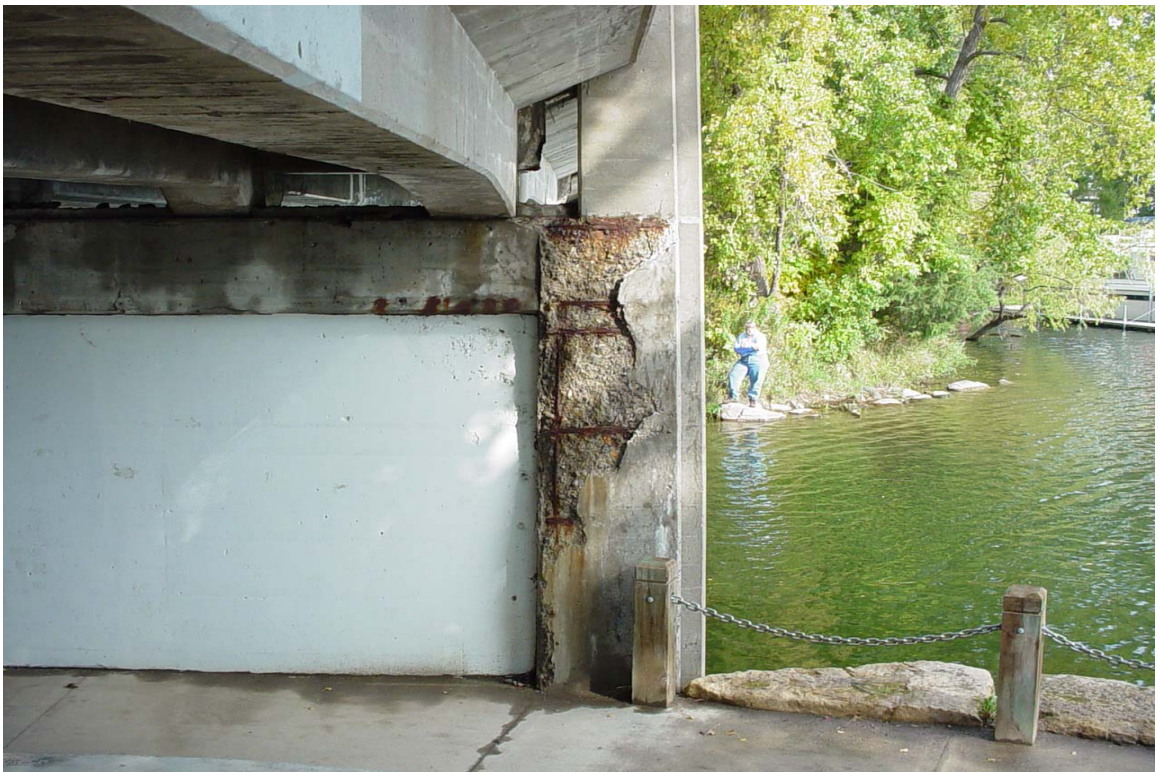
- (A) There were several areas of section loss above the waterline with exposed reinforcing steel on both piers with penetrations of up to 5 inches depth. Pier 1 exhibited an area of section loss at the east end of the pier with exposed reinforcing steel that extended to 1 foot below the waterline.
- (B) Several horizontal cracks were observed on both piers near the waterline. The cracks extended up to 7 feet along the pier shafts and were up to 1/16 inch wide.
- (C) Near the center of each pier a vertical crack was observed extending on both faces of the pier from the cap to the channel bottom with a maximum width of 1/8 inch. There were also some minor areas of section loss and an impending spall at the pier cap related to the cracks.

Photograph 4. View of spall with exposed reinforcement at east end of Pier 1.

- (A) To inhibit further, more detrimental deterioration, repair the areas of section loss by removing all unsound concrete, cleaning the reinforcing steel, and patching with a concrete mix designed to promote high durability and low permeability.
